Fire Examination Reports and FAA Testing Reports

Fire Examination Report (Original On-scene 7/6/13)

Fire Examination Report (Follow-up on-scene visit 8/21-22/13)

Fire Test Results for Asiana 214 Materials

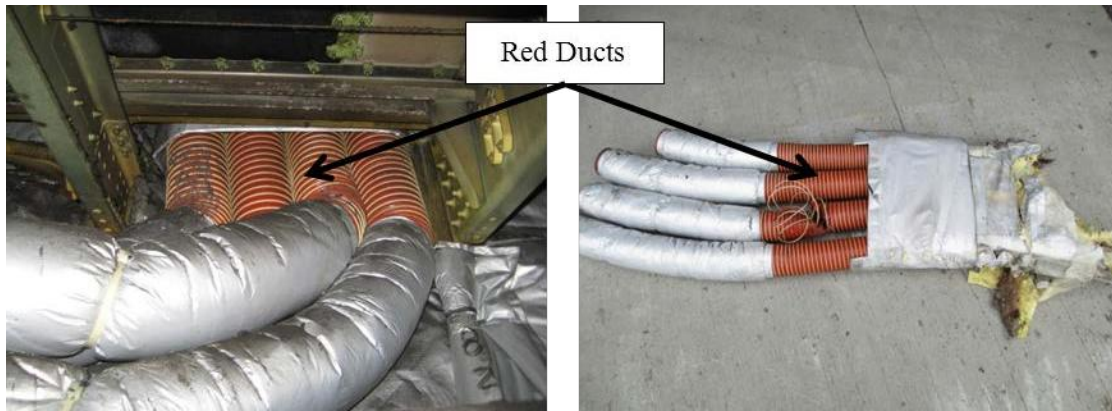
The term “Red Duct” is used to describe the flexible hoses that connect the large mixing duct to the overhead area. The ducts are constructed from silicone impregnated fiberglass, and reinforced with a rigid, white spiral material. The ducts are four inches in diameter, and are wrapped with thermal acoustic insulation along portions of the length. Four of these ducts are placed side-by-side just below the ECS riser bay.

Figure 16. Location of the “Red Ducts” in the cheek area below the floor, going up the ECS riser bay.

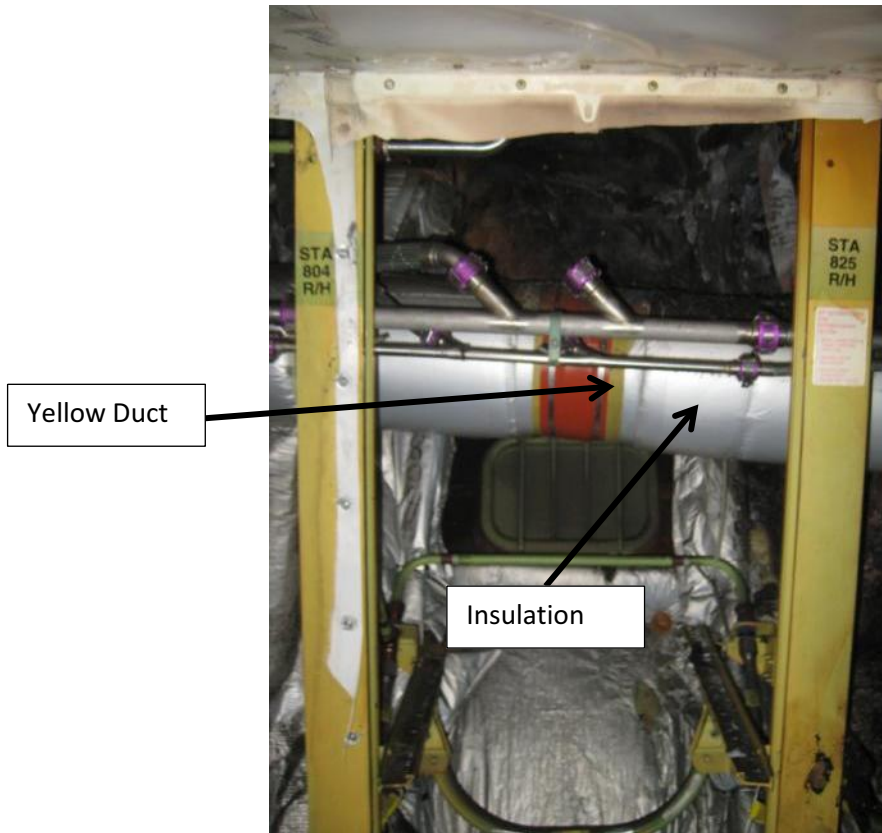
The term “Yellow Duct” is used to describe the large ducts that run parallel to the axis of the aircraft in the cheek area below the floor. These ducts connect the large mixing duct to the red ducts near the riser bay. The yellow duct is a composite material of Kevlar and epoxy construction. The inside diameter is approximately 12 inches. The duct is wrapped in thermal acoustic insulation along most of its length, except for areas where two yellow ducts are joined with a red, silicone coupler. The thermal acoustic insulation on the yellow duct was also recovered for testing. The insulation consisted of a silver film bonded to yellow insulating foam.

Figure 17. Location of “Yellow Duct” and duct insulation in the cheek area behind the cargo liner and below the floor.

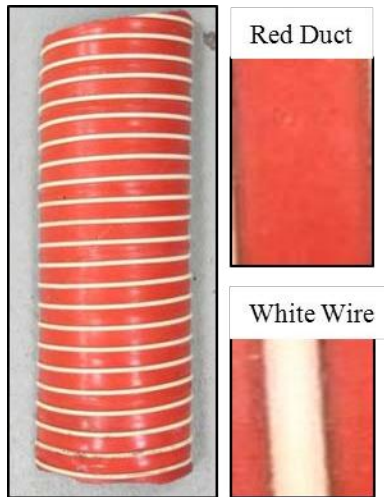
Figure 36. Red duct separated into two individual samples for MCC testing.

Of all the materials tested, the red flexible duct displayed the poorest fire performance when introduced to test methods more severe than the vertical Bunsen burner test that is required for certification. The MCC test results indicated that the white reinforcing spiral wire was actually the most flammable component of the red duct, and when it begins to combust a significant amount of heat is released. This behavior was also observed in the OSU and the vertical flame propagation apparatus, where the radiant heater added significantly more energy to the surface of the sample, elevating the temperature of the red duct and white wire, resulting in self-sustaining flaming combustion and flame propagation along the sample surface. Although the red duct displayed poor fire performance in these tests, the criteria for certification still remains a twelve second vertical Bunsen burner test. Therefore, the material meets and exceeds the current certification criteria for flammability.
